North Water Street Beach Shoreline Resiliency Project

Stakeholder Meeting #2

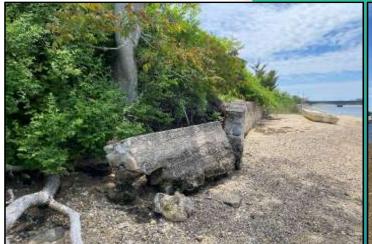
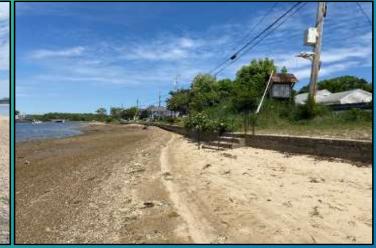
Photos 1, 2 – Deterioration of seawall and low-lying nature of adjacent municipal assets.

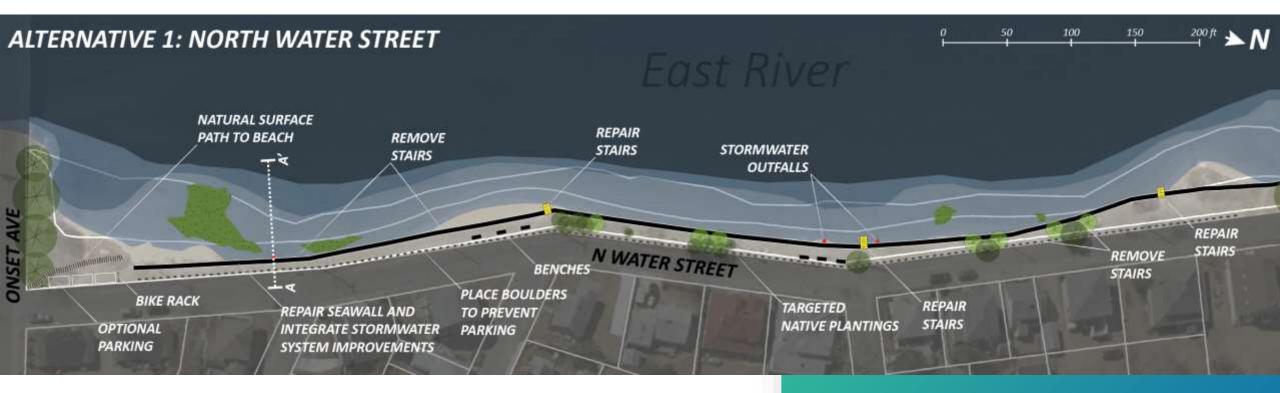
Alternative #1 – Repair Seawall & Resource Area Enhancement

- Repair existing seawall.
- Stabilize eroding bank at corner of N Water St. and Cove St.
- Remove invasive plants & install clustered restoration plantings.
- Repair 3 sets of stairs on N Water St. and 2 sets on Cove St.
- Install natural surface path at the corner of N Water St. and Onset Ave.
- Establish 3 resident parking spaces near the corner of Onset Ave.

- + Likely least expensive
- + Repaired stairs are safer
- + Some habitat improvements
- Not a long-term measure
- No increase in public space

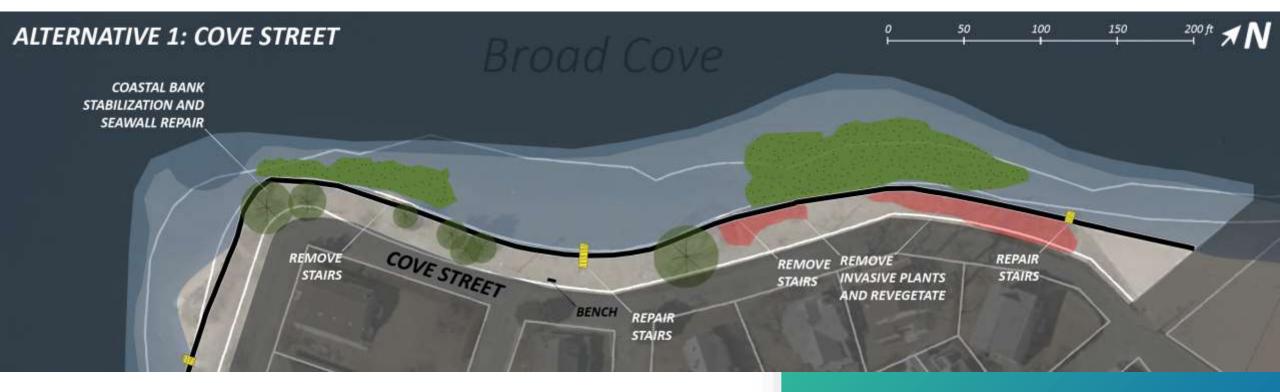
Alternative #1 – Repair Seawall & Resource Area Enhancement

- Repair existing seawall
- Stabilize eroding bank at corner of N Water St. and Cove St.
- Remove invasive plants & install clustered restoration plantings.
- Repair 3 sets of stairs on N Water St. and 2 sets on Cove St.
- Install natural surface path at the corner of N Water St. and Onset Ave.
- Establish 3 parking spaces near the corner of Onset Ave.

- + Likely least expensive
- + Repaired stairs are safer
- + Some habitat improvements
- Not a long-term measure
- No increase in public space

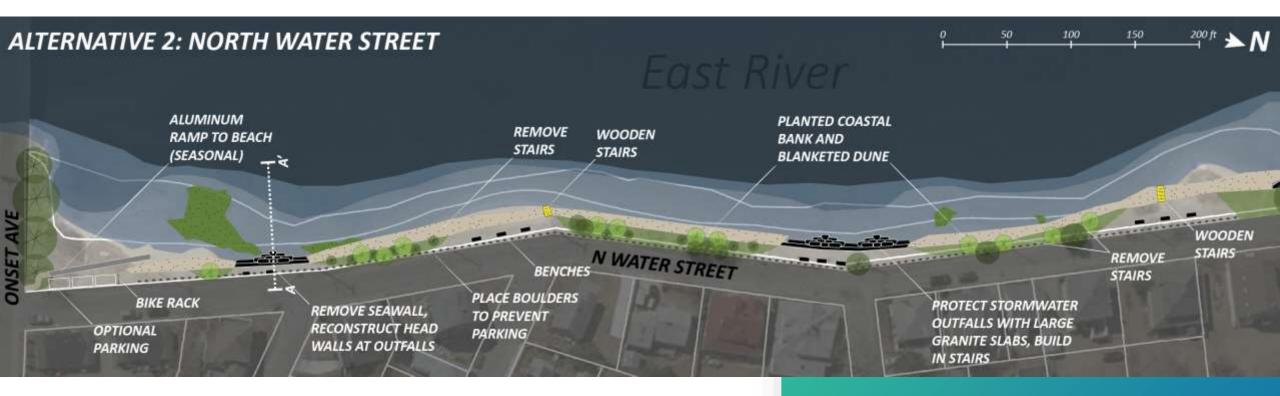
Alternative #2 – Living Shoreline & Resource Area Enhancement

- Remove seawall and replace with living shoreline along N Water St.
- Reconstruct seawall at corner and along Cove St.
- Protect stormwater outfalls and install flood protection berm.
- Salt marsh enhancement along Cove Street.
- Remove invasive plants & install clustered restoration plantings.
- Repair 3 sets of stairs on N Water St. and 2 sets on Cove St.
- Establish 3 parking spaces near the corner of Onset Ave.

- + Maximum habitat improvement
- + Public water access maintained
- Not effective for protecting infrastructure
- Higher cost
- Slight reduction in public space

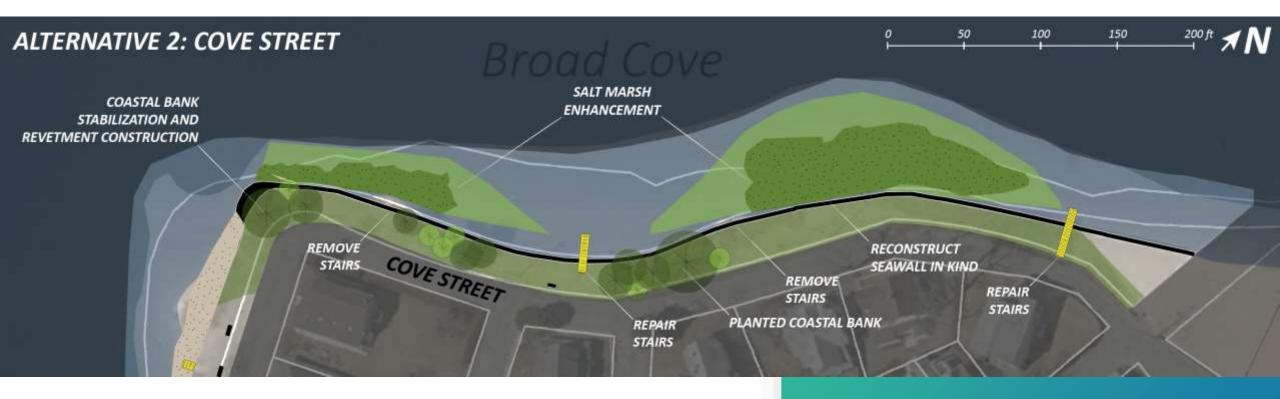
Alternative #2 – Living Shoreline & Resource Area Enhancement

- Remove seawall and replace with living shoreline along N Water St.
- Reconstruct seawall at corner and along Cove St.
- Protect stormwater outfalls and install flood protection berm.
- Salt marsh enhancement along Cove Street.
- Remove invasive plants & install clustered restoration plantings.
- Repair 3 sets of stairs on N Water St. and 2 sets on Cove St.
- Establish 3 parking spaces near the corner of Onset Ave.

- + Maximum habitat improvement
- + Public water access maintained
- Not effective for protecting infrastructure
- Higher cost
- Slight reduction in public space

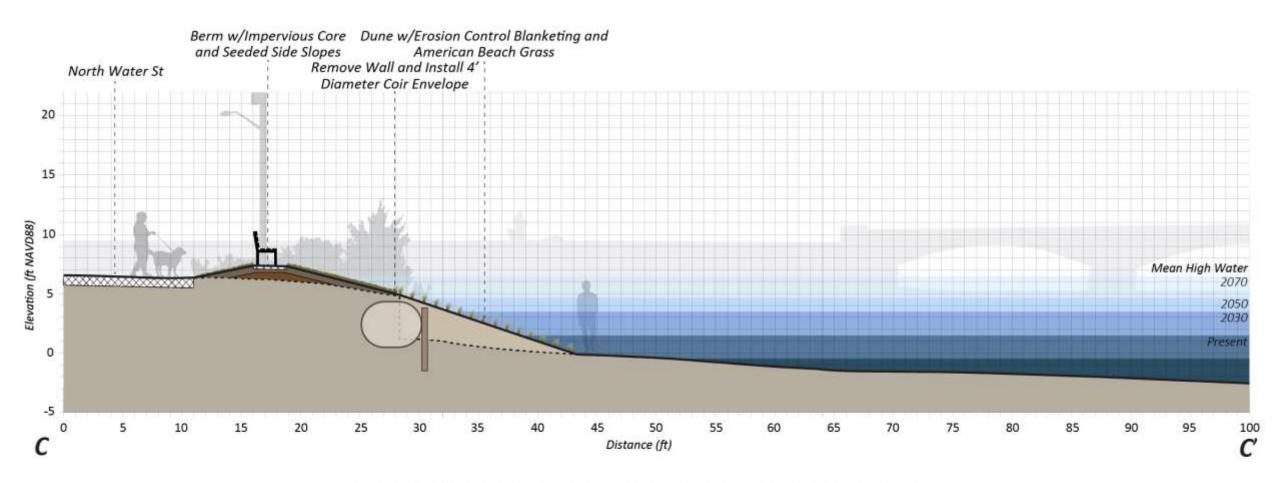
REMOVE WALL AND INSTALL SOFT EROSION CONTROL

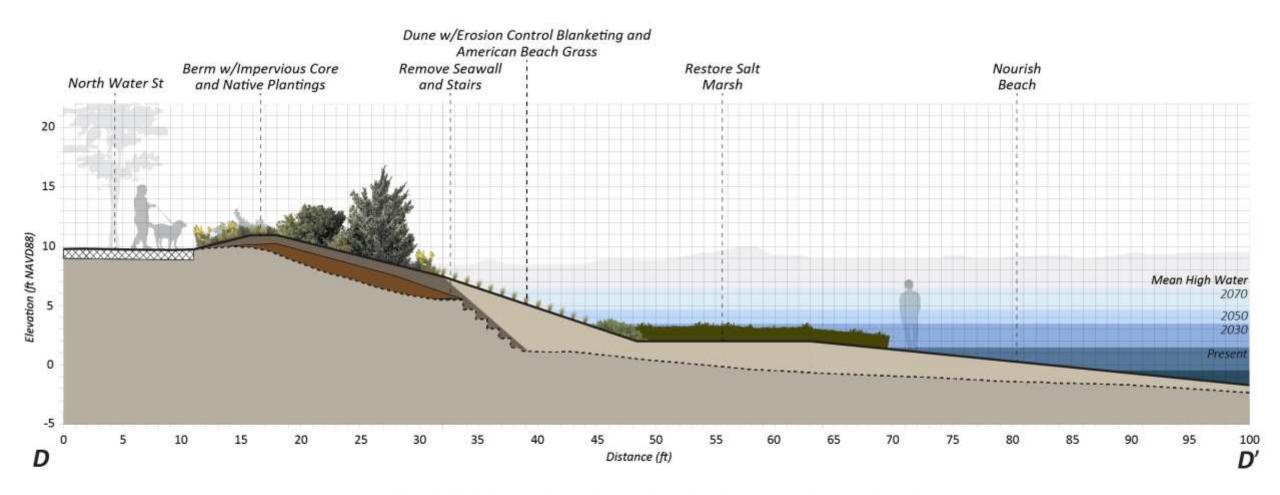
REMOVE WALL AND INSTALL SOFT EROSION CONTROL

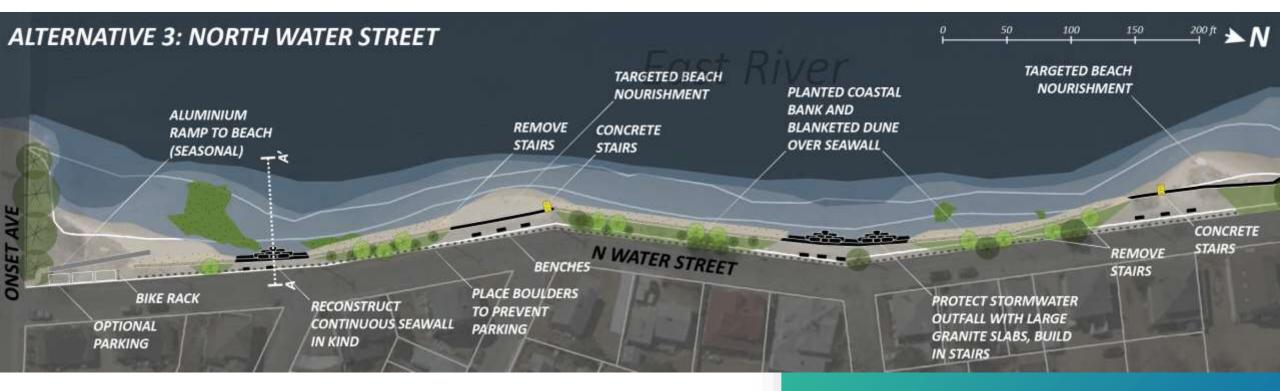
Alternative #3 – Replace Seawall & Resource Area Enhancement

- Reconstruct seawall and outfalls along N Water St. and Cove St.
- Nourishment and plantings extend over seawall in places.
- Salt marsh enhancement along Cove St.
- Remove invasive species and install clustered restoration plantings.
- Rock revetment to stabilize coastal bank at corner.
- Repair 3 sets of stairs on N Water St. and 2 sets on Cove St.
- Establish 3 parking spaces near the corner of Onset Ave.

- + Maximum habitat improvement
- + Public water access maintained and beach space increased
- Highest cost
- Slight reduction in occupiable public space

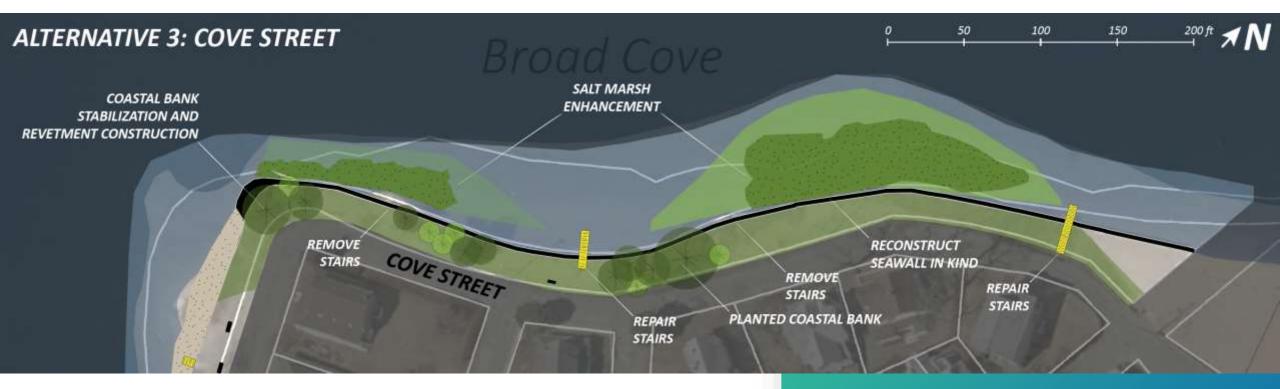
Alternative #3 – Replace Seawall & Resource Area Enhancement

- Reconstruct seawall and outfalls along N Water St. and Cove St.
- · Nourishment and plantings extend over seawall in places.
- Salt marsh enhancement along Cove St.
- Remove invasive species and install clustered restoration plantings.
- Rock revetment to stabilize coastal bank at corner.
- Repair 3 sets of stairs on N Water St. and 2 sets on Cove St.
- Establish 3 parking spaces near the corner of Onset Ave.

- + Maximum habitat improvement
- + Public water access maintained and beach space increased
- Highest cost
- Slight reduction in occupiable public space

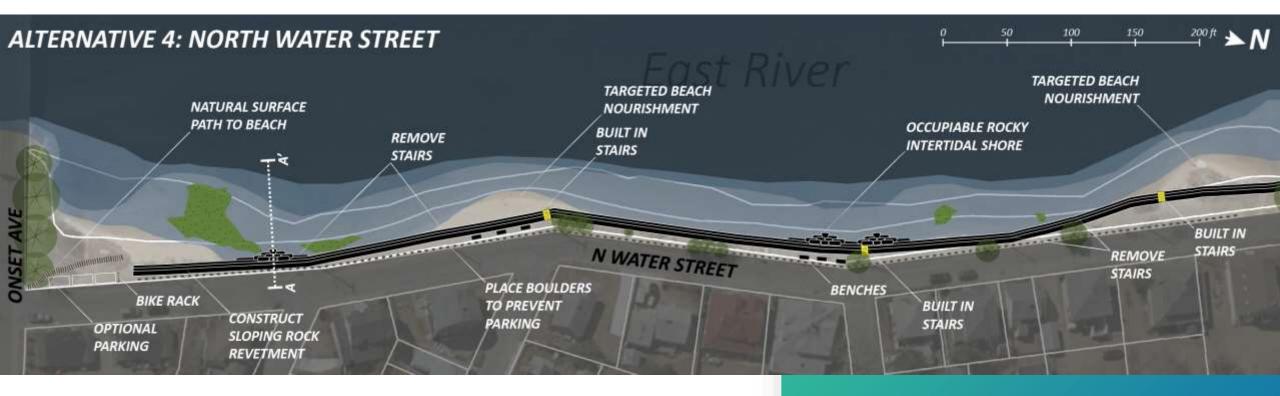
Alternative #4 – Rock Revetment & Resource Area Enhancement

- Replace seawall with rock revetment along N Water St. and Cove St.
- Reconstruct stormwater outfalls.
- Targeted beach nourishment.
- Enhance existing salt marsh along Cove St.
- Remove invasive species and install clustered restoration plantings.
- Repair 3 sets of stairs on N Water St. and 2 sets on Cove St.
- Establish 3 parking spaces near the corner of Onset Ave.

- + Resilient to waves and currents
- + Public water access maintained and beach space increased
- High cost
- Loss of coastal bank
- Loss of open space

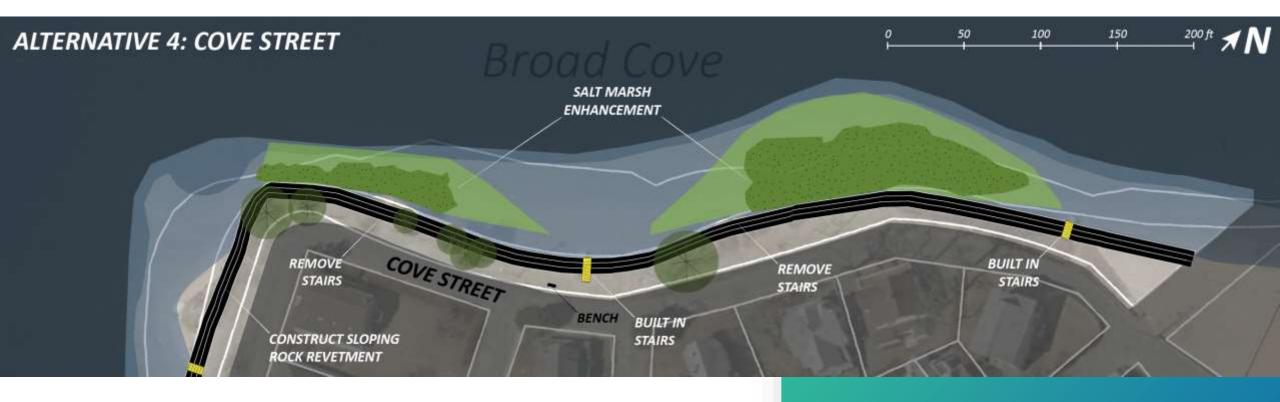
Alternative #4 – Rock Revetment & Resource Area Enhancement

- Replace seawall with rock revetment along N Water St. and Cove St.
- Reconstruct stormwater outfalls.
- Targeted beach nourishment.
- Enhance existing salt marsh along Cove St.
- Remove invasive species and install clustered restoration plantings.
- Repair 3 sets of stairs on N Water St. and 2 sets on Cove St.
- Establish 3 parking spaces near the corner of Onset Ave.

- + Resilient to waves and currents
- + Public water access maintained and beach space increased
- High cost
- Loss of coastal bank
- Loss of open space
